State of Utah
DEPARTMENT OF NATURAL RESOURCES
DIVISION OF OIL, GAS AND MINING

RE: Site Inspection, Plateau Resources, Inc. Tony M/Lucky Strike & Frank M Mines, M/017/001 & S/017/017, Garfield County, Utah

Date of Inspection: November 19, 2003
Time of Inspection: 9:30 AM to 12:30 PM
Conditions: Clear, Sunny, 50's
Participants: Fred Craft – U.S. Energy Corp, Jim Butt – Contractor; Tom Munson & Wayne Hedberg, DOGM

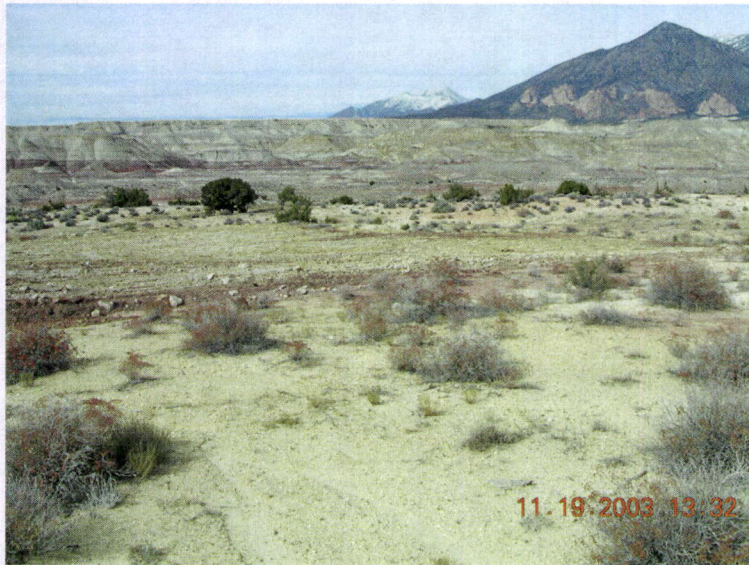
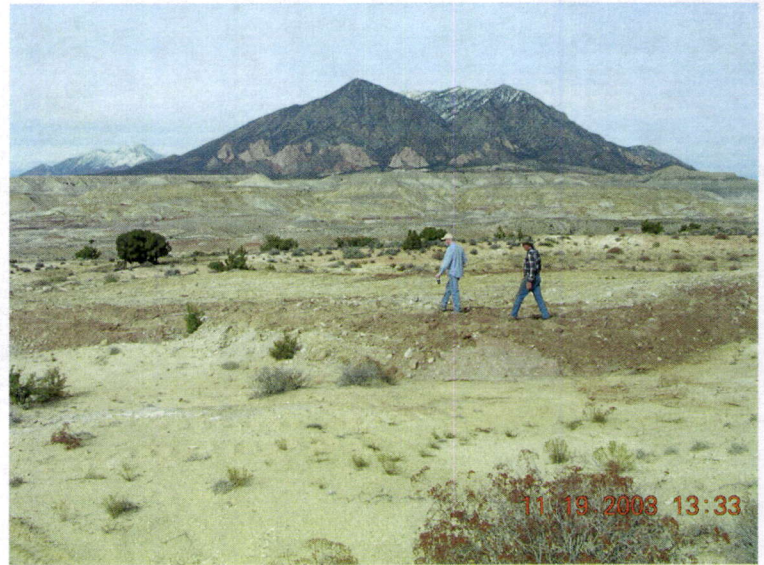
Mine area recontouring work

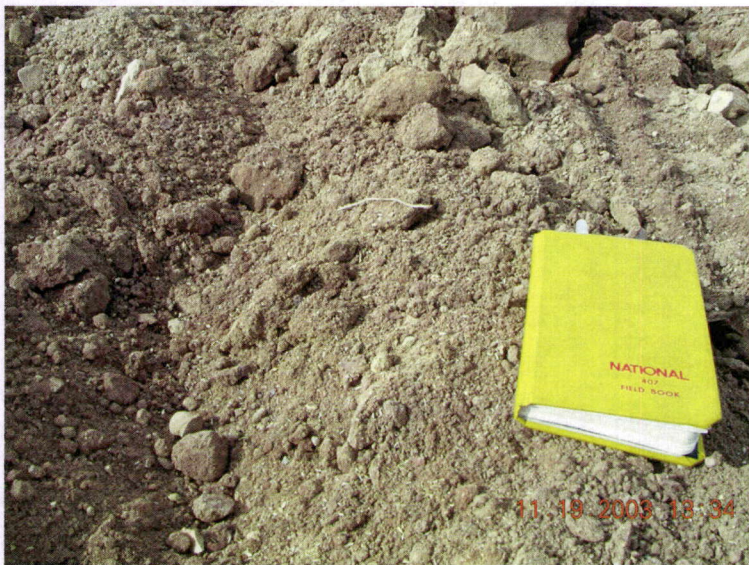
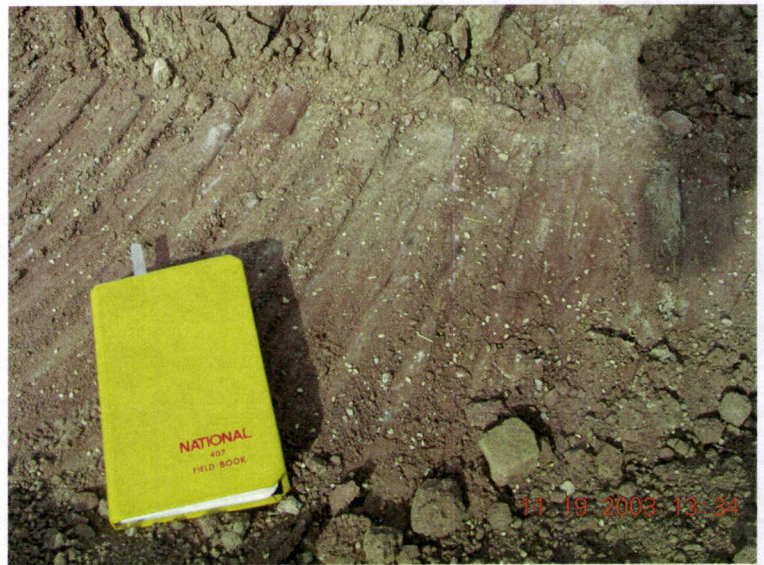
broadcast seeding evidence mine area

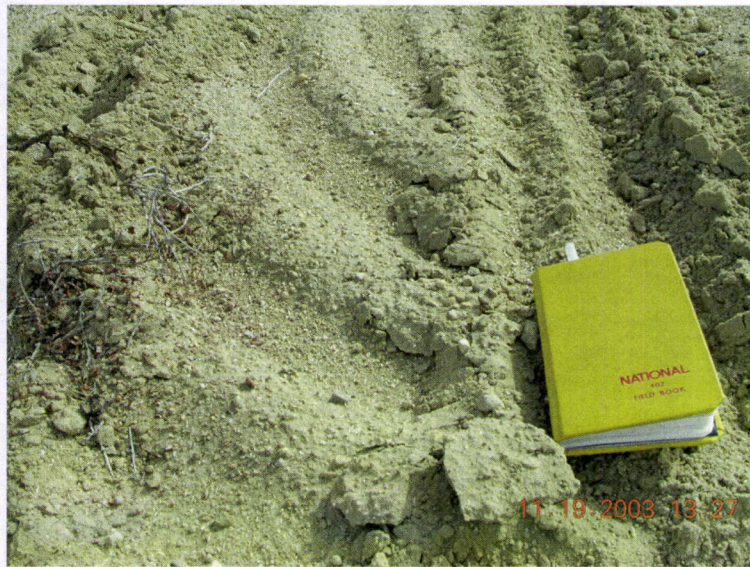
Broadcast seed
(ore storage area)

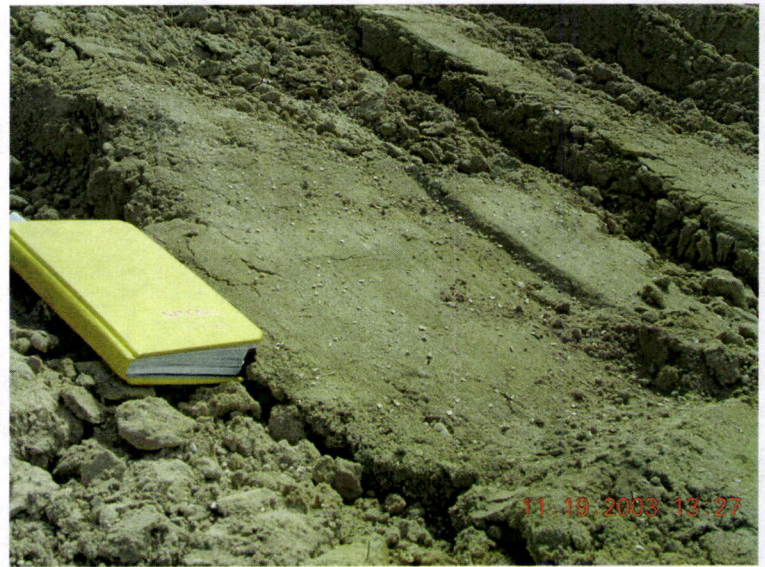
Broadcast seed
(ore storage area)

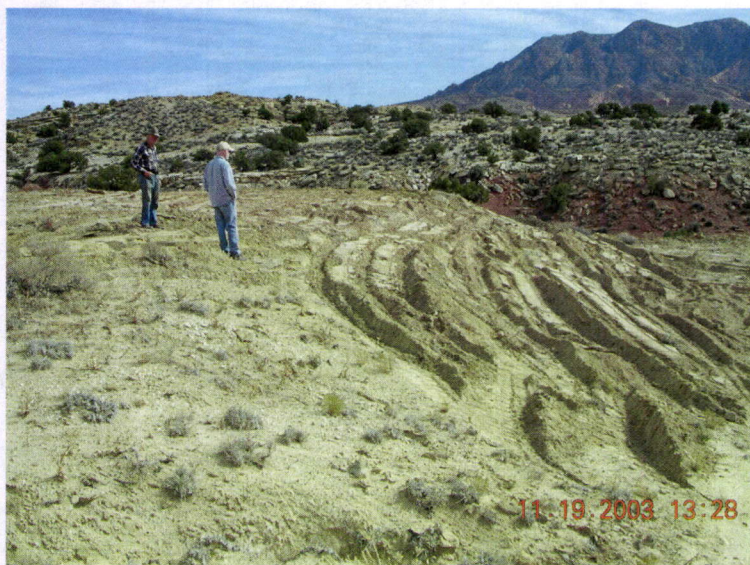
Ore storage bin-loadout area

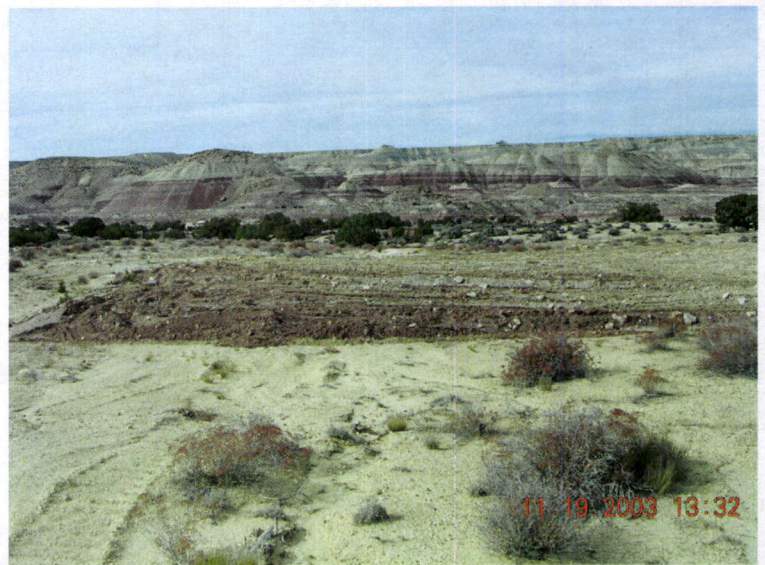
Recontoured mine decline
area

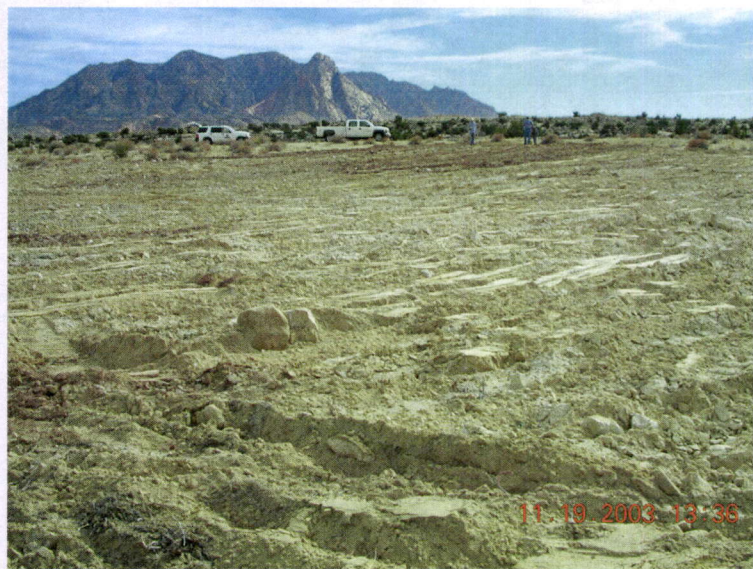
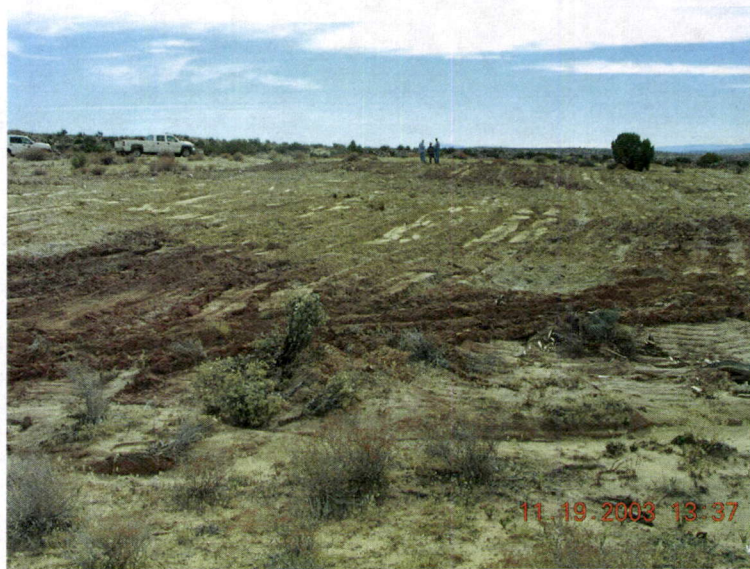
recontouring & seeding work - mine area
